Landslide Control in the Rockies: An Example

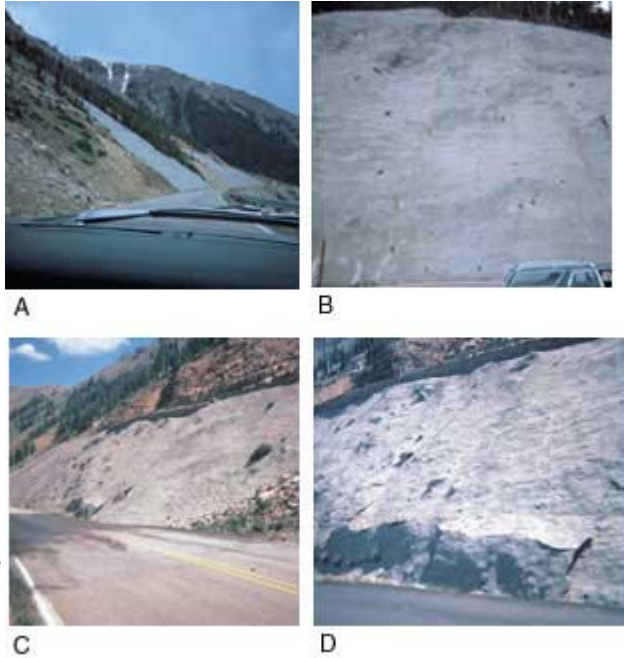
shown in figure 8.28A. The slopes are frighteningly steep; the guardrails are dented from falling boulders. Spring is an especially dangerous time because when the soil is sodden from melted snow, it slides especially readily, often taking sections of road with it. The road is critical to local transportation and has, therefore, been regularly rebuilt after each slide.

Two decades or so ago, an attempt was made to stabilize several large expanses of the most slide-prone slopes by applying concrete to the slope surface (figure 1A-D). Realizing the danger of having water accumulate behind these concrete sheets, building up weight and pore pressure, the engineers added drainage holes (B). A return visit three summers later strongly suggested that this solution was not an unqualified success. The slope had continued to move, and the thin concrete sheets had buckled and cracked in many places (C,D). Furthermore, some very new asphalt below one such barrier (C) showed that the spring outwash had claimed the soil *underneath* the roadway there as well.
